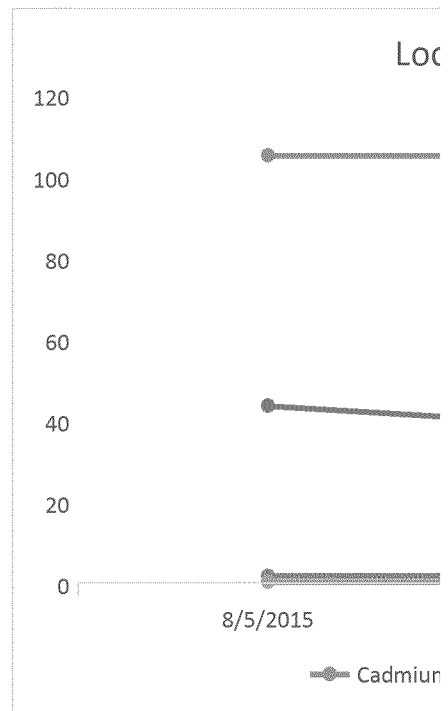
Location: 32nd Street Bridge

ocation ID	Date Sampled	Cadmium	Copper	Lead	Manganese	Zinc
32nd St Br	8/5/2015	0.178	1.7	0.24	105	43.5
32nd St Br	8/6/2015	0.16	1.56		105	37.8
32nd St Br	8/6/2015	0.19	1.62	0.115	97.8	49.1

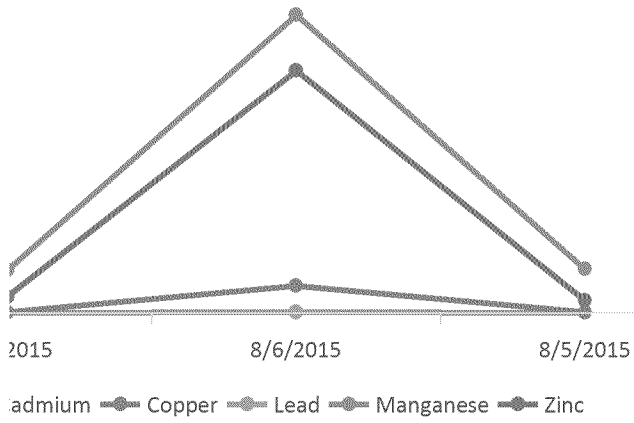
Location: Bakers Bridge

Location ID	Date Sampled	Cadmium	Copper	Lead	Manganese	Zinc
Bakers Bridge	8/6/2015	0.336	1.88		296	110
Bakers Bridge	8/6/2015	5.32	189	1.56	2090	1700
Bakers Bridge	8/5/2015	0.353	2.28		306	85.8
